Client: Phillip

Clinician: Diana Hoopes, PT

Equipment Breakage

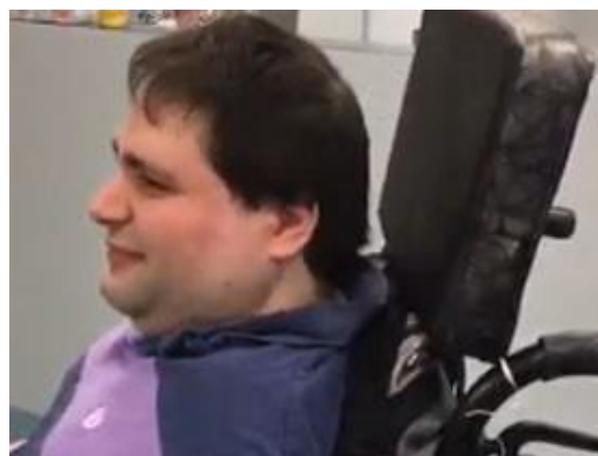
Phillip was seen in May of 2017 with his team of therapists at his residential center. He was positioned in a Quickie IRIS tilt in space manual wheelchair with a Jay Custom Fit linear back and a Stimulite cushion. He also had a wide, flat head support; lateral trunk supports; pelvic positioning belt; and lateral thigh supports. Although he was fairly well positioned, his constant rocking had led to increased wear and tear on his wheelchair frame and seating system.

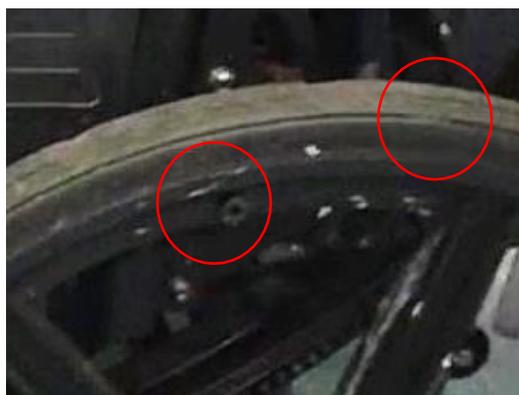
Phillip's caregivers used the wheel locks to prevent the wheelchair from moving across the room in response to his rocking. He exerted so much force behind his movements that the solid tire had actually broken around the wheel lock numerous times – the tire looked like a monster had been taking bites out of it!

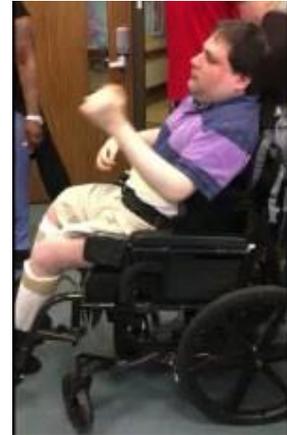
Phillip needs to move. He seeks out movement, craving this vestibular input. Research has demonstrated that movement can reduce agitation and increase alertness. He required movement at his pelvis, knees, and neck. He had movement at his pelvis, but the Quickie Dynamic Back was not working correctly. He had a dynamic component on the footrest hanger, but he was not activating it as this did not match his movement pattern. He also required durable components that he would not break.

A Seating Dynamics Dynamic Rocker Back interface (DRBi), Dynamic Footrests and Dynamic Head Support Hardware were recommended for Phillip. He has since received this equipment. His therapists report that he can move much more readily and greatly enjoys these components. Since receiving the new Dynamic Seating, he has not broken anything on his wheelchair or seating system. The DRBi is locked during transport, and he does not like that. He is greatly relieved once this is unlocked after he arrives at his destination!
