Client: Phillip

Clinician: Diana Hoopes, PT

Location: Wilmington, Delaware

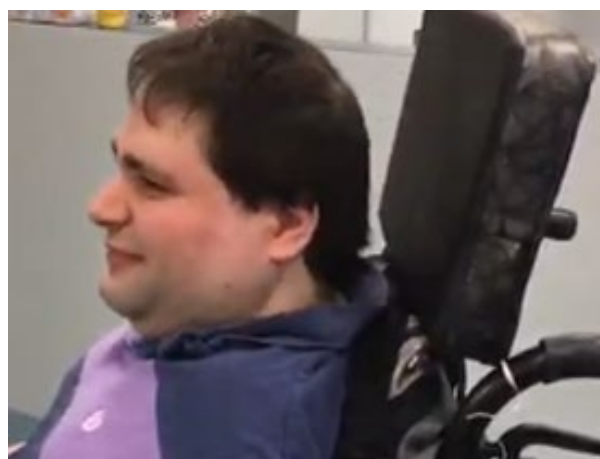
Phillip was seen in May of 2017 with his team of therapists at his residential center. He was positioned in a Quickie IRIS tilt in space manual wheelchair with a Jay Custom Fit linear back and a Stimulite cushion. He also had a wide, flat head support; lateral trunk supports; pelvic positioning belt; and lateral thigh supports. Although he was fairly well positioned, his constant rocking had led to increased wear and tear on his wheelchair frame and seating system.

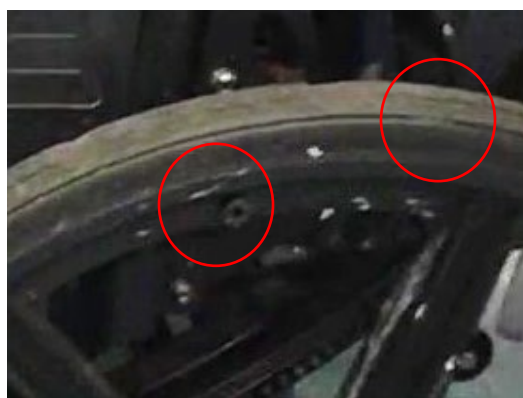
Equipment Breakage

Phillip's caregivers used the wheel locks to prevent the wheelchair from moving across the room in response to his rocking. He exerted so much force behind his movements that the solid tire had actually broken around the wheel lock numerous times – the tire looked like a monster had been taking bites out of it!
