Client: Thulfeqar

The Need to Move

Dynamic Seating

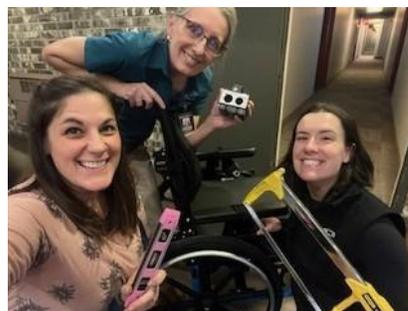
Left to right: Isabel Castelnovo-Hoffman, Caroline, and Kristen Decker with level, hacksaw, and Seating Dynamics PN 6100 Jig.

Not wanting a repeat of the damage which occurred to the prior manual wheelchair and loaner, the team recommended a Dynamic Back. Most of Thulfeqar’s movement came from his hips and a Dynamic Back would provide that movement in response to his forces. A Seating Dynamics Dynamic Rocker Back interface was ordered and installed by the team at Handi Medical.

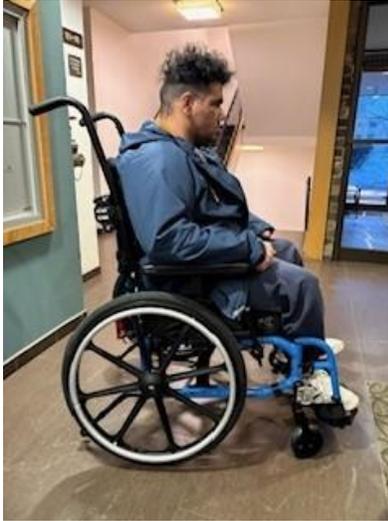
The recommended equipment was approved by funding and delivered at the end of 2025. As he has just received this equipment, we plan to update this case study in the future with his progress. So far, the Dynamic Back responds to his movements and Thulfeqar appears to enjoy this movement.
